Drone IR (DIR) Inspection Service

艾思特能源股份有限公司

ExTEL Drone IR Inspection & Services

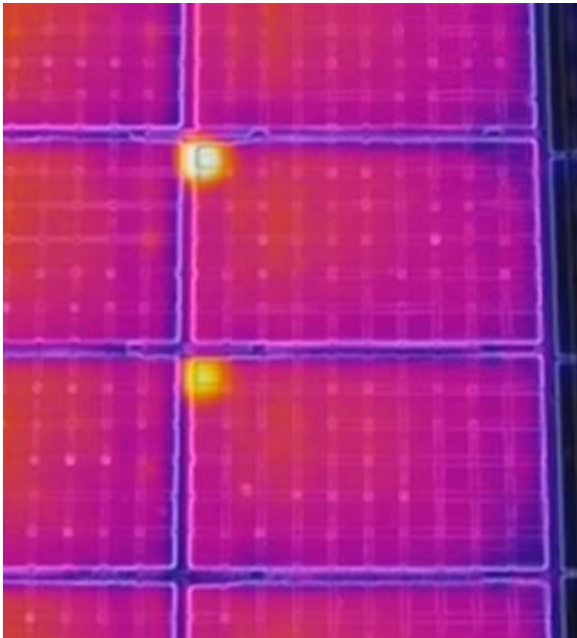
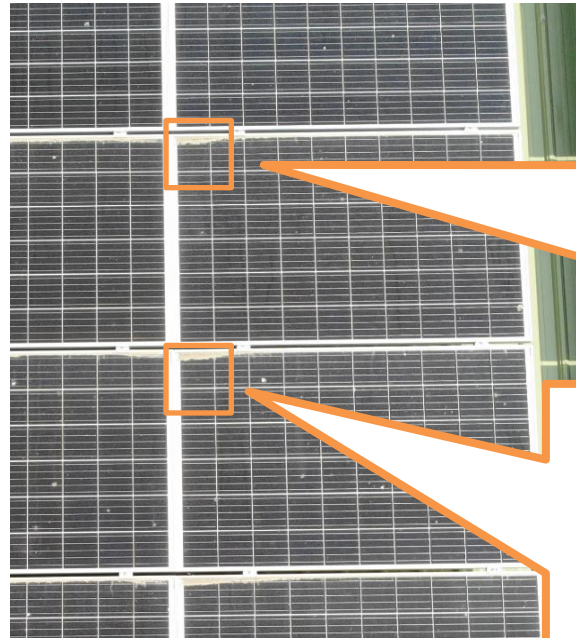
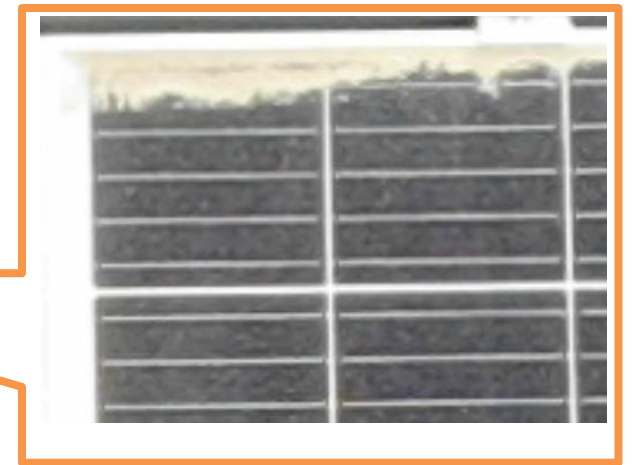
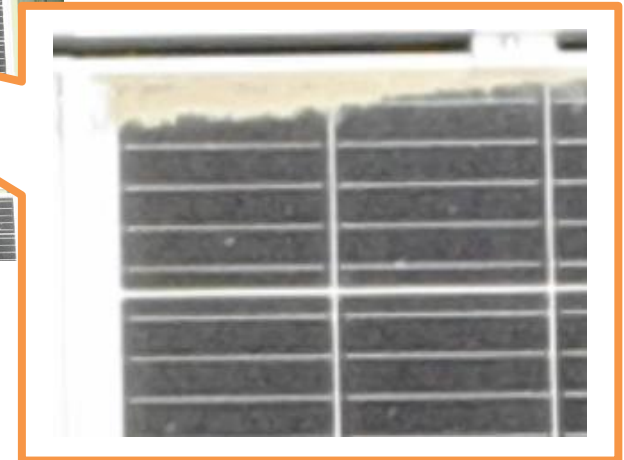
DIR Inspection Case Study. 1 (Soiling hot spot)

- ❑ Residual soiling on the module surface can cause hot spots, reduce PV efficiency and bring safety risk

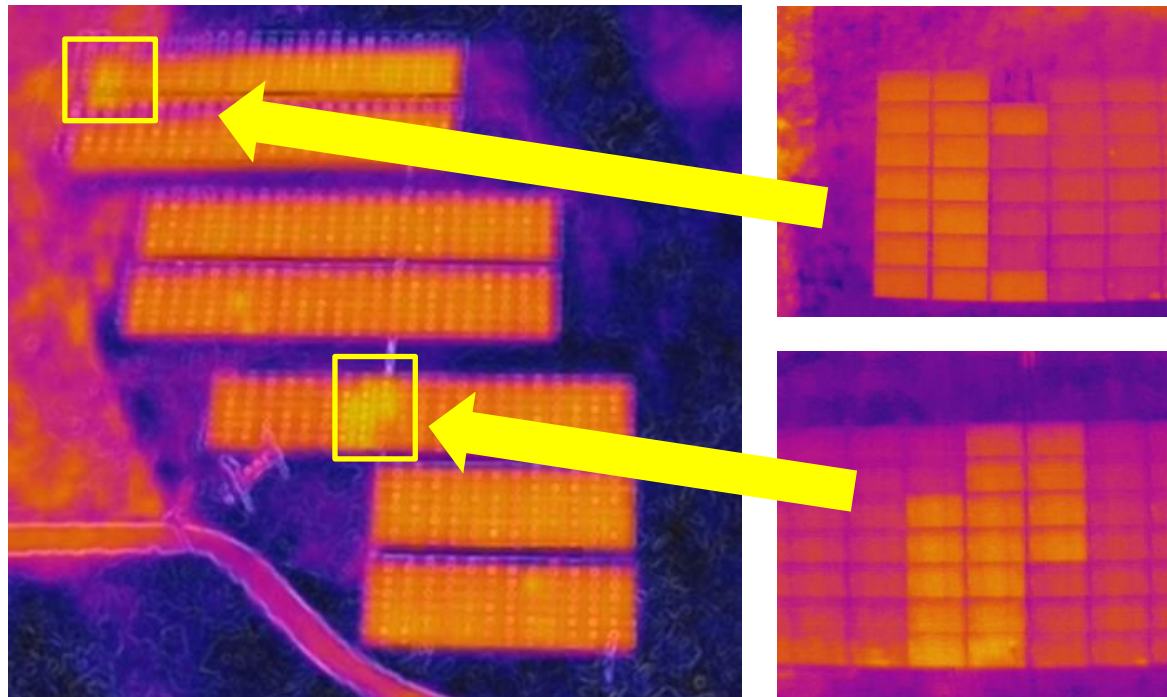
DIR Inspection Case Study. 3 (String not on-grid)

- ❑ Stings not on-grid will show higher working temperature compare to the normal strings

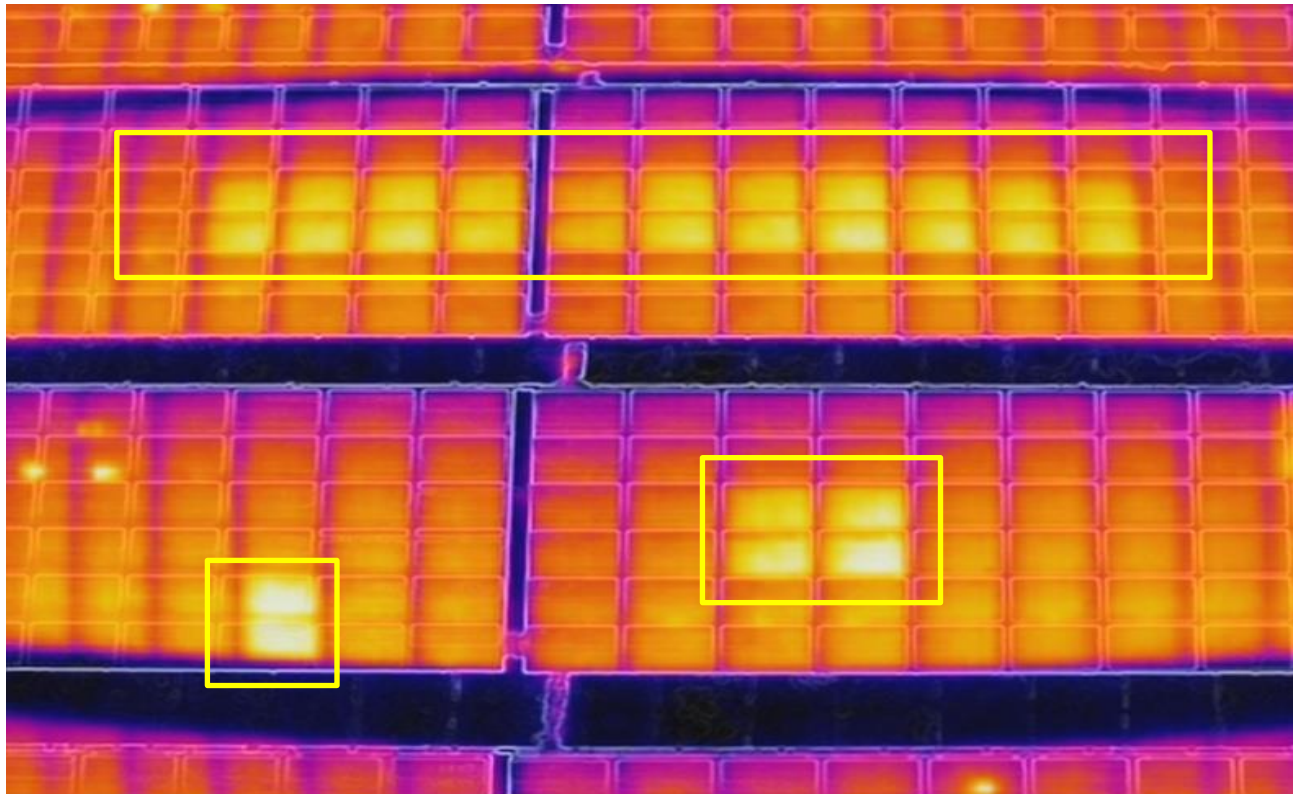
DIR Inspection Case Study. 4 (Optimizer abnormal)

- ❑ Optimizer malfunction, such panels/strings will show higher working temperature compared to the normal panels/strings

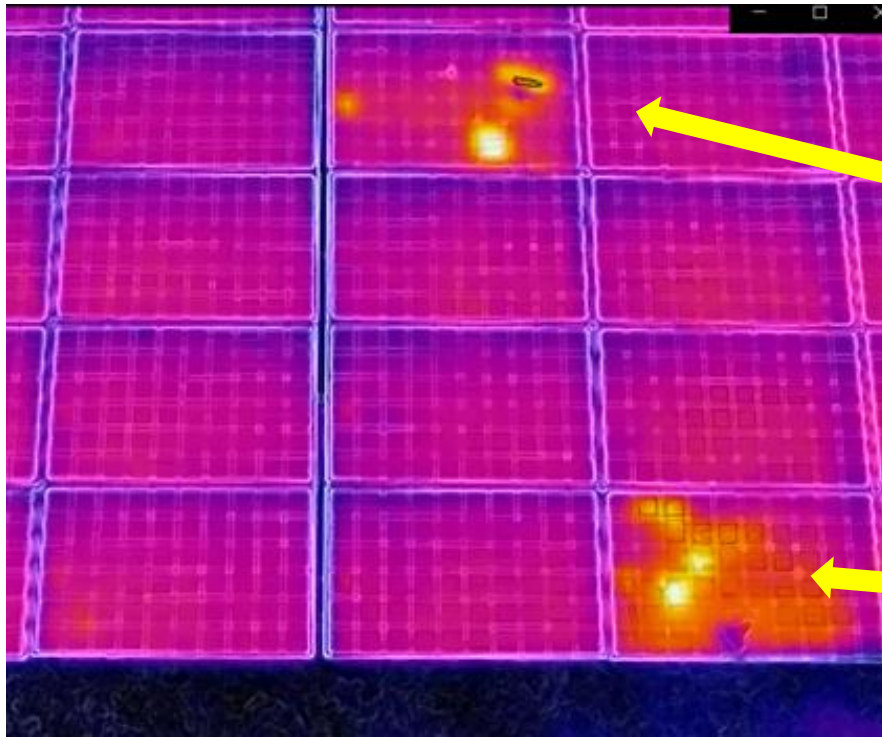
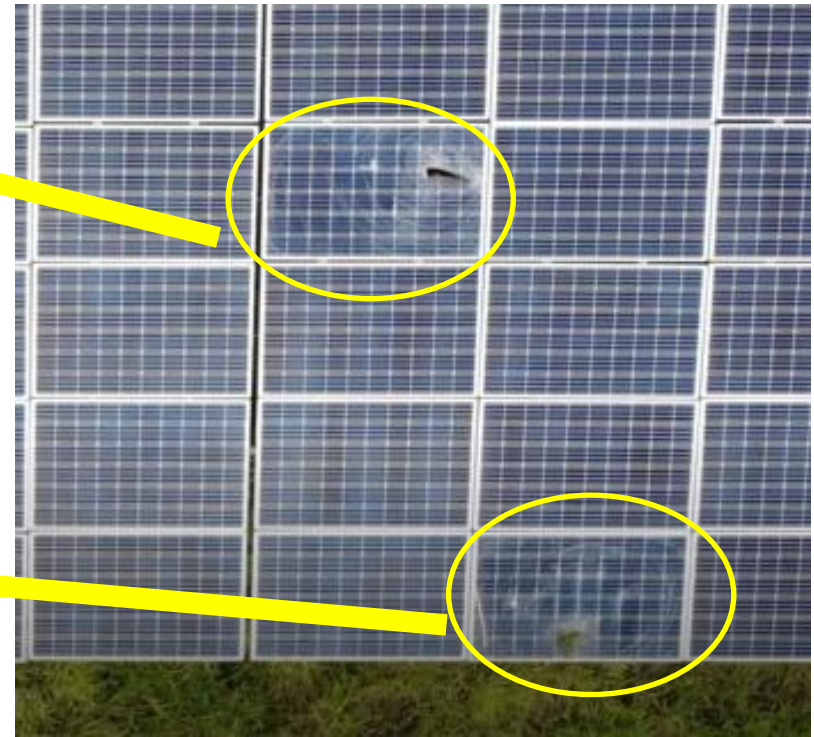
DIR Inspection Case Study. 5 (PV panel broken)

- ❑ PV panel broken, such panel should be replaced ASAP to avoid safety hazard

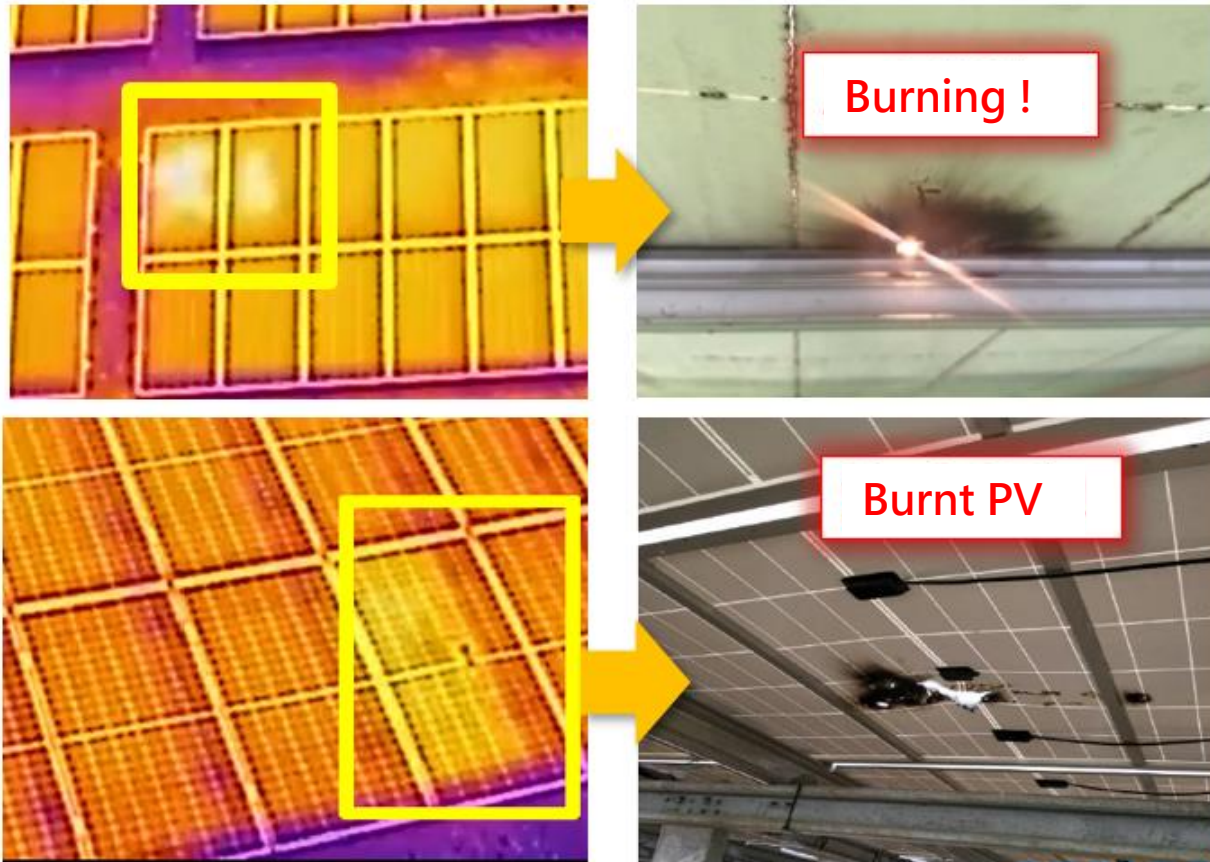
DIR Inspection Case Study. 6 (PV broken & burning)

- ❑ PV panel broken, such panel should be replaced ASAP to avoid safety hazard

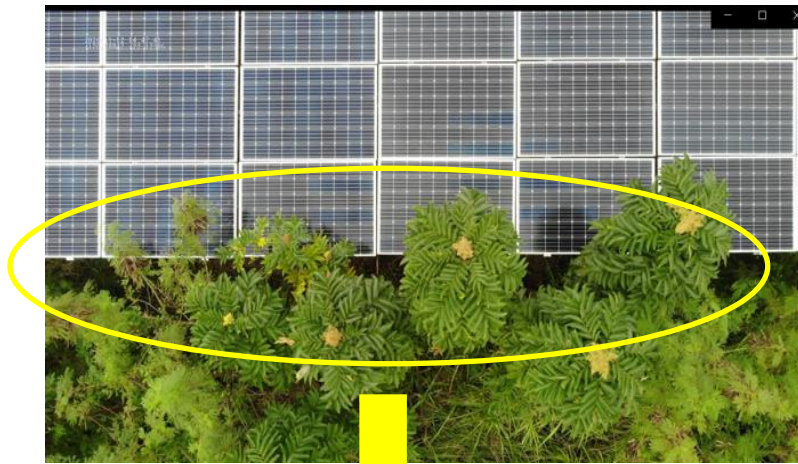
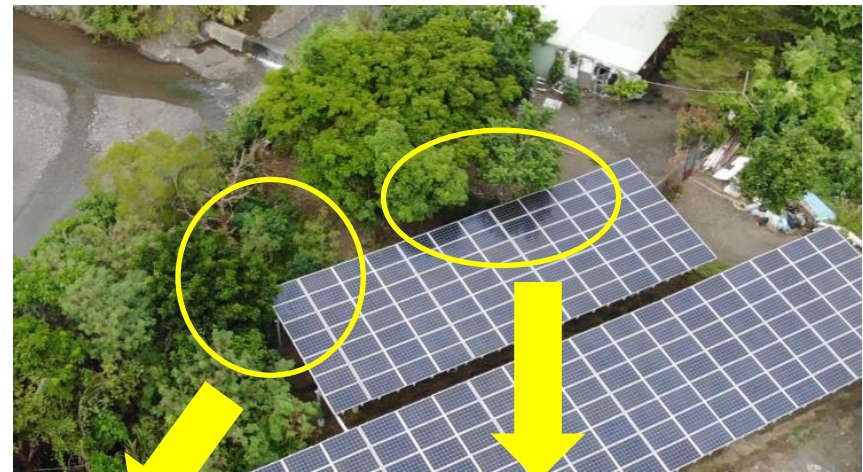
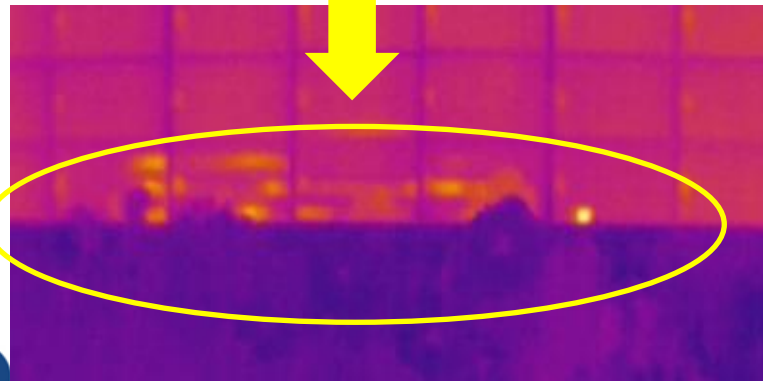
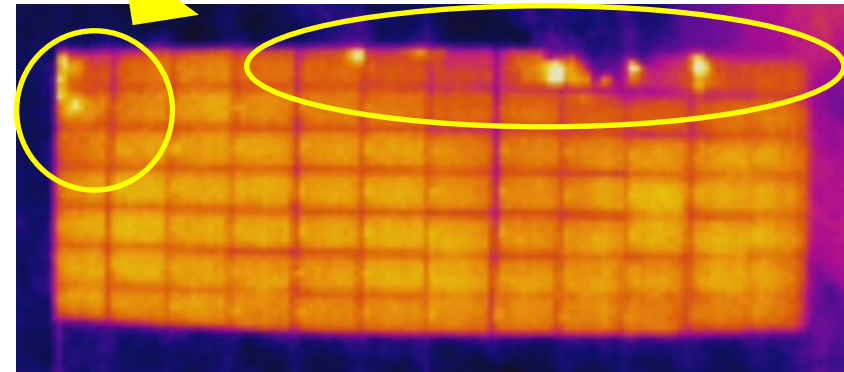
DIR Inspection Case Study. 7 (Shading by trees)

- ❑ Shading near the PV array causing hot spots, which reduce PV efficiency and bring safety risks

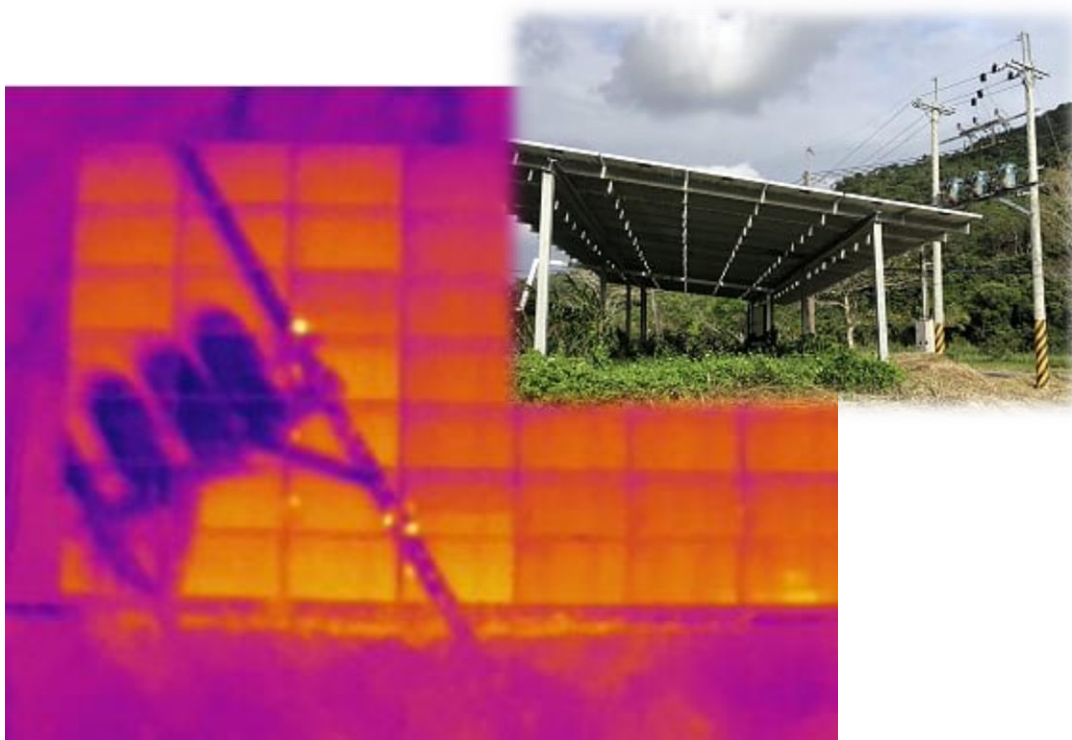
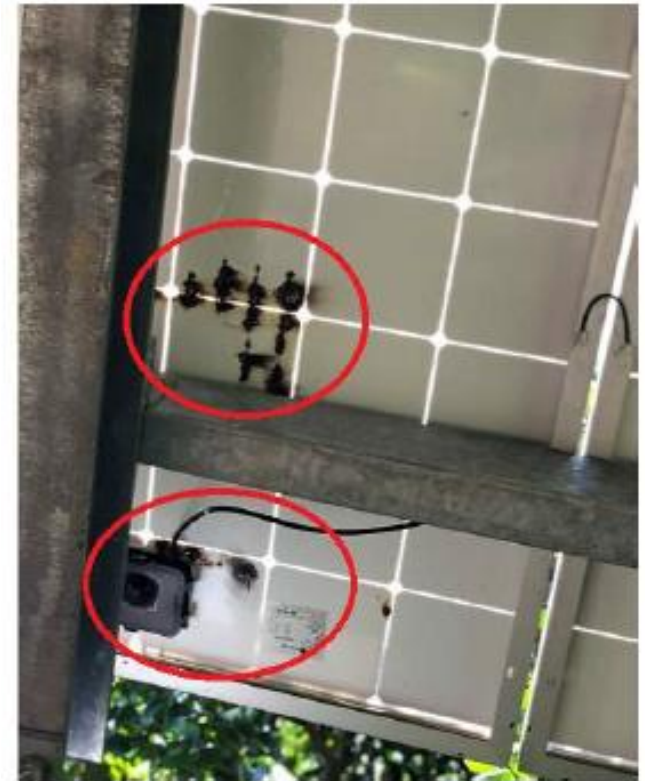
DIR Inspection Case Study. 8 (Shading by pole)

- ❑ Objects(Poles) near the PV array causing hot spots, which reduce PV efficiency and bring safety risk

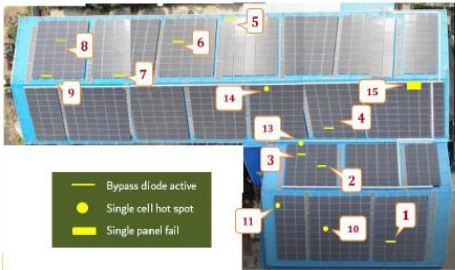
Table 4.1.3.2 ③ DIR: PV module Thermal Image inspection result																
Item	Contents			Remark												
Abnormality Summary	<table><thead><tr><th>Abnormality</th><th>Count</th><th>CoA(*)</th></tr></thead><tbody><tr><td>Bypass Diode active</td><td>9</td><td>2</td></tr><tr><td>Cell hot spot</td><td>3</td><td>2</td></tr><tr><td>PV panel fail</td><td>1</td><td>2</td></tr></tbody></table>			Abnormality	Count	CoA(*)	Bypass Diode active	9	2	Cell hot spot	3	2	PV panel fail	1	2	Failure ratio: 1.3%
	Abnormality	Count	CoA(*)													
	Bypass Diode active	9	2													
	Cell hot spot	3	2													
PV panel fail	1	2														
Abnormality Location

<table><tr><td>Class of Abnormality (CoA)</td><td>1 (no abnormalities – OK)</td><td>2 (thermal abnormality – 1A)</td><td>3 (safety relevant thermal abnormality – 2B)</td></tr><tr><td>Recommendation for actions</td><td>No imminent action</td><td>Checking the cause and, if necessary, rectification in a reasonable period.</td><td>Prompt interruption of operations, checking the cause and rectification in a reasonable period.</td></tr></table>			Class of Abnormality (CoA)	1 (no abnormalities – OK)	2 (thermal abnormality – 1A)	3 (safety relevant thermal abnormality – 2B)	Recommendation for actions	No imminent action	Checking the cause and, if necessary, rectification in a reasonable period.	Prompt interruption of operations, checking the cause and rectification in a reasonable period.

- IR report will be provided to customer 3 days after the inspection; and report will cover the abnormality, CoA, locations of the defects and suggested actions
